PUDGE'S RESTORATION

THE STORY SO FAR...

By Peter Boss

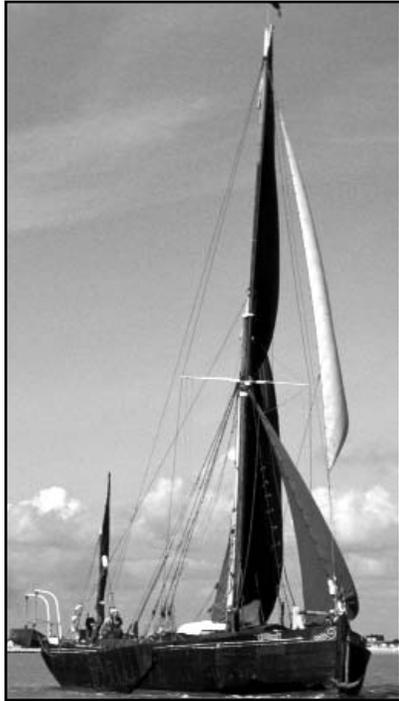
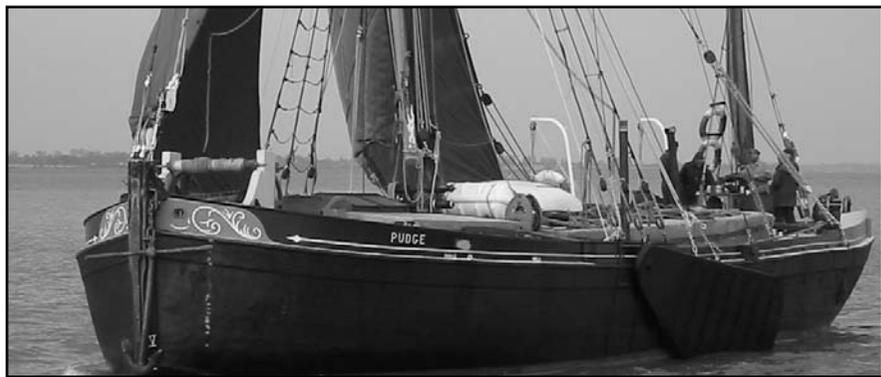
The picture on the top right shows Pudge sailing in 1996 and the drooping shape of her bows shows up by comparison with the picture at the bottom of the page taken in 2003 after the bows had been rebuilt as described in this article. However the drooping stern is also apparent in the sheer line under the vang fall in the more recent picture. Photographs by Martin Phillips.

In the spring of 1997 while Pudge was on the blocks I got the Maldon shipwrights to make a close examination of the hull. This revealed that the underneath of the hull at the round of the bow was very badly worn. The keel where it protrudes below the planking at the stem was worn down by about 8 inches, the wear extending aft for about 30 feet but gradually tapering off giving the bows a pronounced and noticeable droop (as the photographs show).

We decided we would have to put Pudge into a dry dock and remove her stem and apron (see diagram 2) and the planks below the waterline so that her bows could be jacked up to get back the original shape. A new section of keel 30 feet long would need to be fitted together with several upright frames and floors with navel frames (diagram 1) joining them together. She would probably need new forward frames to the deadwood knee and a new stem and apron. It was estimated that this would cost £45,000. We did not have the money to pay for this but we estimated that with subscriptions and charter deposits coming in early in 1998 we could afford to do the job

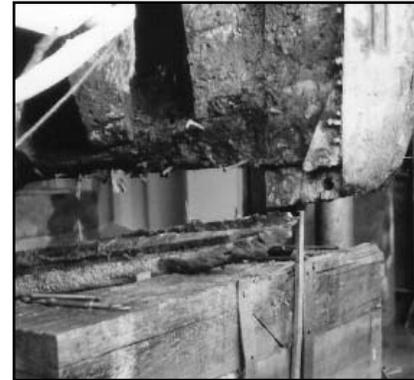
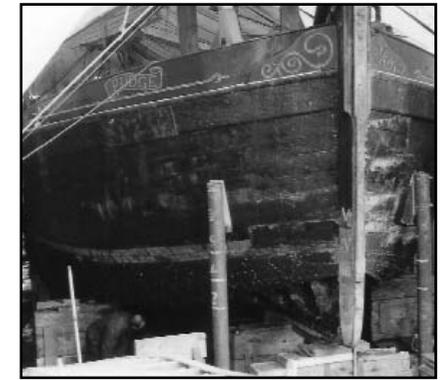
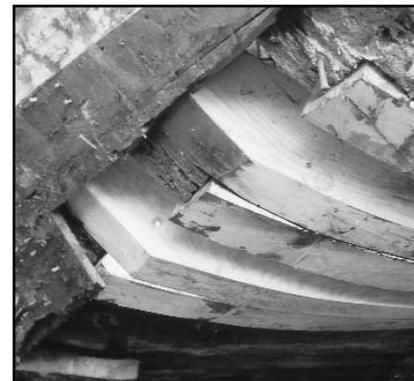
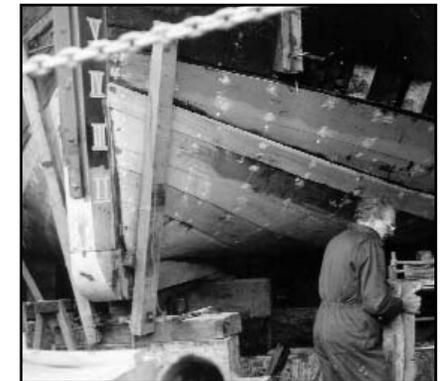
From top left to bottom right: The rotten keel removed; the jacked up bows; new floors and frames; shipwright Baden at work on the new runs of planking in to the bottom of the barge and the chines. Photographs Pat and Peter Boss.

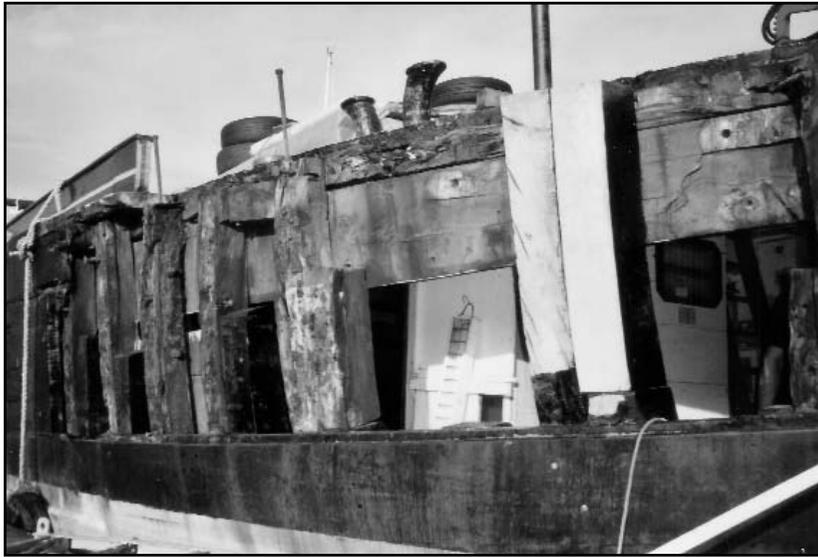
The starboard bow planking removed. Photograph Pat and Peter Boss.

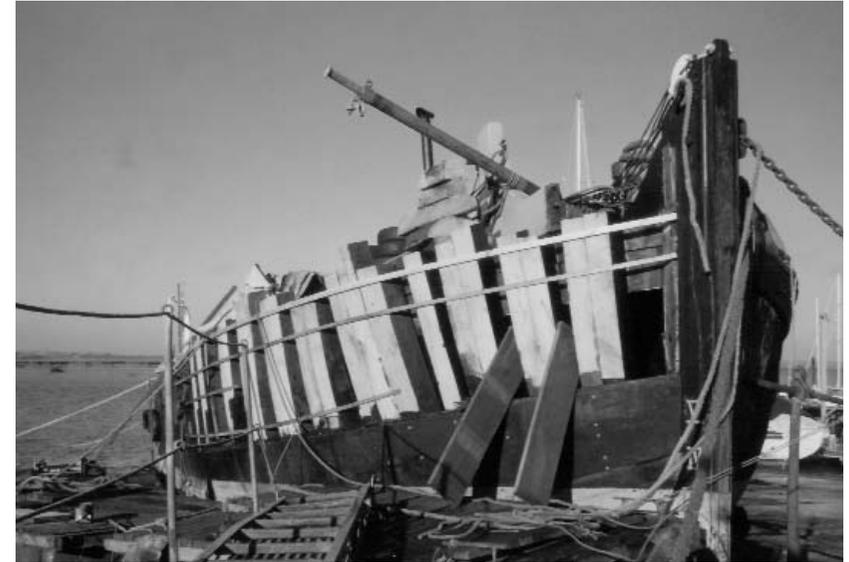
Re-framing in progress 2001. Photograph Pat and Peter Boss.

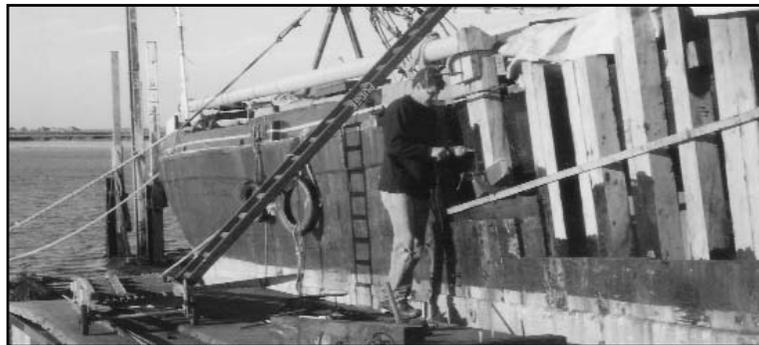
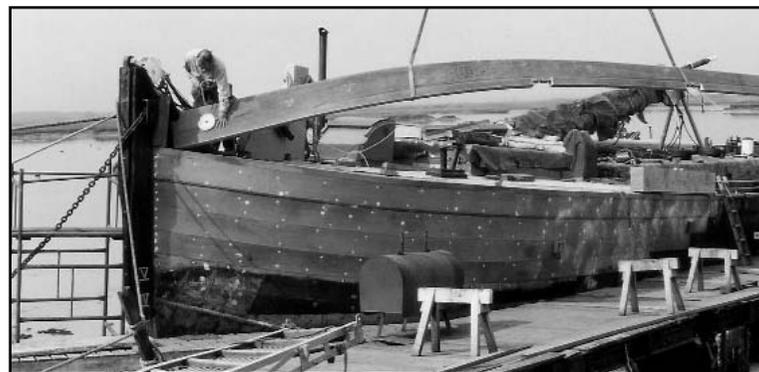
Above: new frames on the starboard side. Below the new rail is fitted on the port bow.

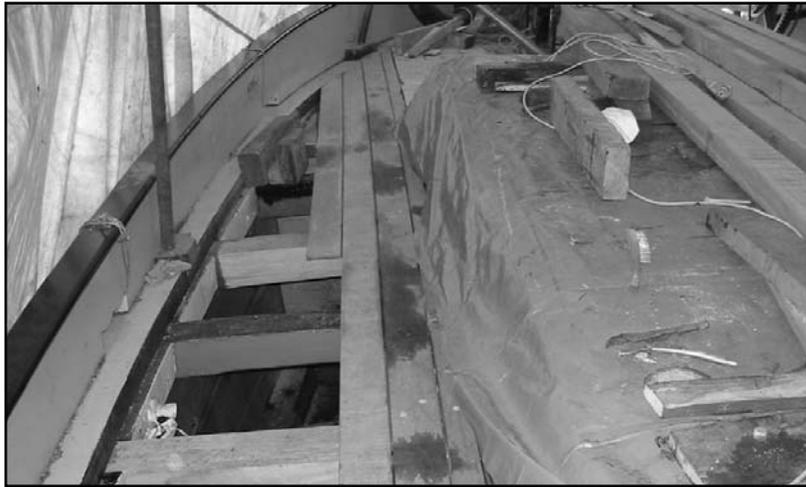
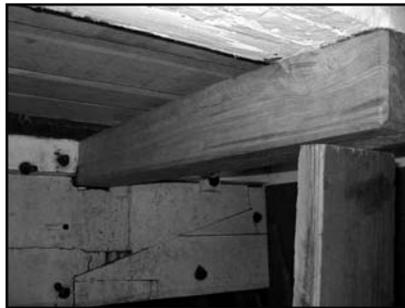
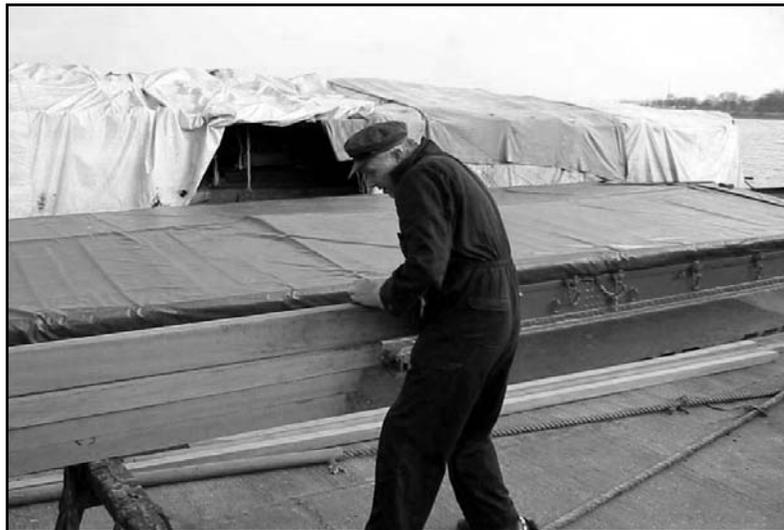
a tent over the barge to protect her from the elements and removed the old planking. This revealed a worse state than had been expected as several carlings (half beams) which appeared sound from below had actually rotted from their top surfaces so would have to be renewed as well. This caused our first delay.

Above: new deck planking laid. Left: one of the new deck carlings in propped in place for fastening. Below Phil Chatfield works on the scarf joints while Pudge lies under the tent in the background.
Photographs by Martin Phillips.

The timber for the deck was opepe purchased locally but unfortunately only available in 16 foot lengths which necessitated cutting extra scarf joints when gluing them together to make full length planks to fill a now 75 feet x 5 feet gap down the port side of the barge. Before scarfing together the planks all had to be planed to the same width and a caulking seam cut in each one. This part of the job is very time consuming and we were getting further behind until Phil Chatfield arranged for the remaining timber to be collected by one of his contacts, taken away, thickened and delivered back to Maldon. Member James Byam Shaw also stepped in by machining the remaining scarfs at his Heybridge workshop and we were able to progress to gluing the planks. Unfortunately the high moisture content of the wood, the damp weather and cold tem-

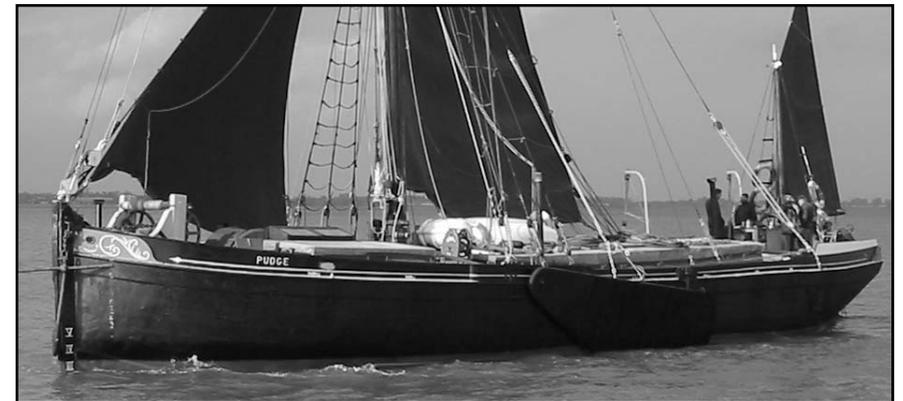
Below: Pudge 2003. Picture Martin Phillips.

Pudge's stern is beginning to droop. This is not unusual in old wooden barges after they have been operating for some years carrying 12 people instead of being deep loaded with 150 or so tons of cargo. When unladen the stern sits high out of the water supported only by the buoyant box like centre trying unsuccessfully to hold up several tons of rudder, stern post, steering gear and transom. The stern will have to be jacked up to its original position and completely rebuilt. There are more rotten frames amidships and in the after runs, and rotten spots in the chine keelson (see diagram 4). Her sagging hatch coamings, already mentioned, will have to be renewed along with the deck king
