PUDGE'S RESTORATION

THE STORY SO FAR...

By Peter Boss

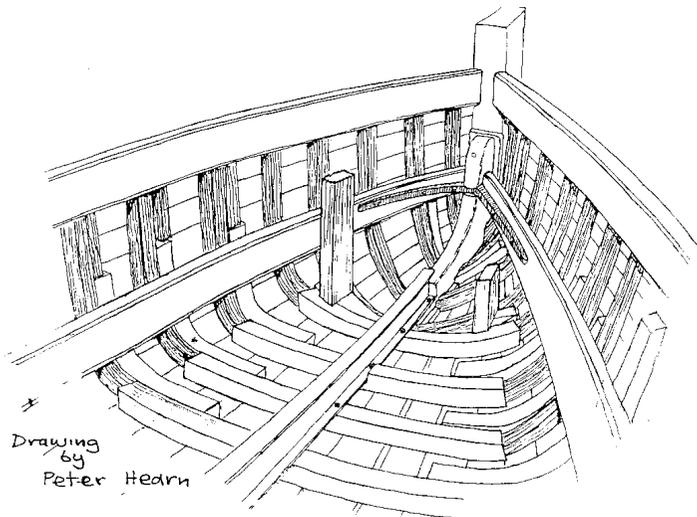
Diagram 3

etc to obtain access to the internal structure of the bows (see diagram 3 below). We also cleared out several tons of the waste timber stacked round the floor of the dry dock.

Removing the doubling and the fo'c'sle interior gave us a far better view of what we were dealing with. Much of the problem with Pudge's bows was not rot but damage. The port underchine plank was cracked right through. The chine is the edge between the side and the bottom of the barge. It consists of two large planks at least four inches thick,

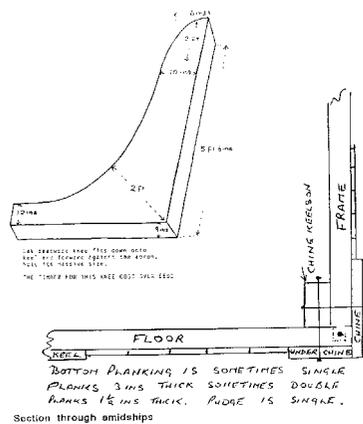
Diagram 4

one on each edge of the chine as well as an inner chine keelson (see diagram 4). Replacement of the chine would need a 26 foot plank bent right round the bow to the stem. Two of the main beams under the deck were broken at the ends where they fit to the barge sides were cracked. She also had numerous cracked floors (frames which go across the bottom) side frames and planks. The force needed to crack right through ten inch thick oak timbers must be huge. But doubtless two collisions a sinking and a

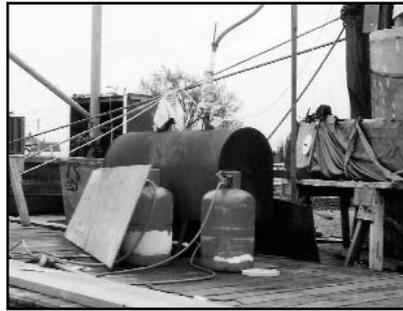
*The boiler used to steam the planks so that they would bend in to shape on the hull.
Photograph Pat and Peter Boss.*

The shipwrights had now reached the stage of re-planking. We were able to buy an elm log which cut enough for the first 3 planks each side which include the garboard planks which are closest to the keel and have a 90 degree twist within the first 6 feet back from the stem. The rest was done in larch. Although this does not bend as well as elm it can be bought in the longer lengths needed for the outer planks. Pudge's planks are 3 inch thick and to obtain the bend and twist needed involves cutting the planks to shape, steaming them to soften the resins and then cramping them in place for 24 hours before finally fastening them in position.

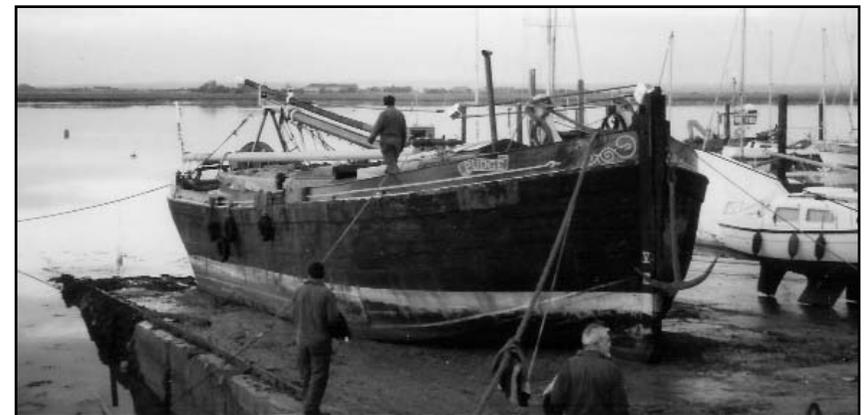
Pudge on the slipway at Maylandsea in October 2000. Photograph Pat and Peter Boss.

Work was able to resume in October 2000 when I took Pudge to Cardnell's Yard at Maylandsea just down the river from Maldon and 15 minutes by car. Rick Cardy who had lead the shipwrights at Maldon was now working independently and agreed to take on replacement of the starboard bow above the waterline assisted by Kevin Finch. Tim Jepson had volunteered to take care of Centaur back at Maldon and I continued to manage the Pudge project. Kevin Burtonshaw, who as most of you know is one of our senior mates and has been working with us for over 20 years, agreed to supervise work on Pudge at weekends which, although I still attended, relieved me of a lot of the pressure.

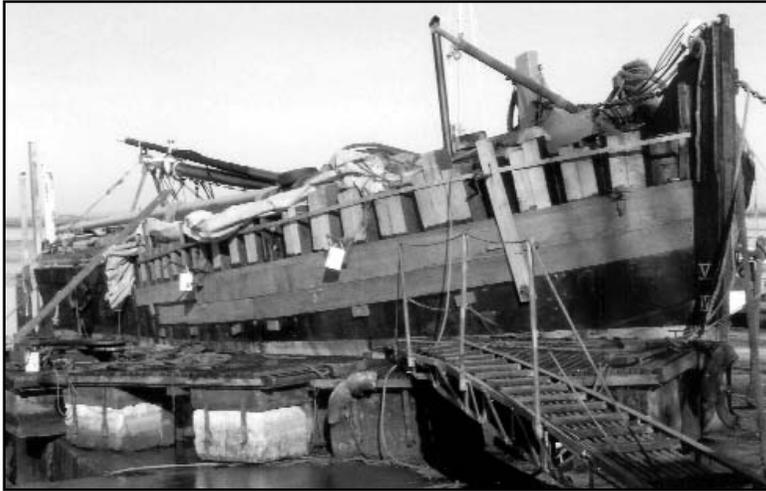
Planking up the starboard bow 2001. Photographs Pat and Peter Boss.

The next job was planking which moves much faster than framing. The outside of the hull is built of two layers of 1½ inch thick planks with caulking between. This thickness does not require steaming to bend it round the bow but the wale does. (a 3inch thick plank 15 inches wide which forms the top of the hull). The 41 feet long plank had to be steamed for about 3 hours to soften the resin allowing it to bend. Instead of a steam box, the traditional method, they used the "boil in the bag technique". This is better for long heavy planks as they can be kept

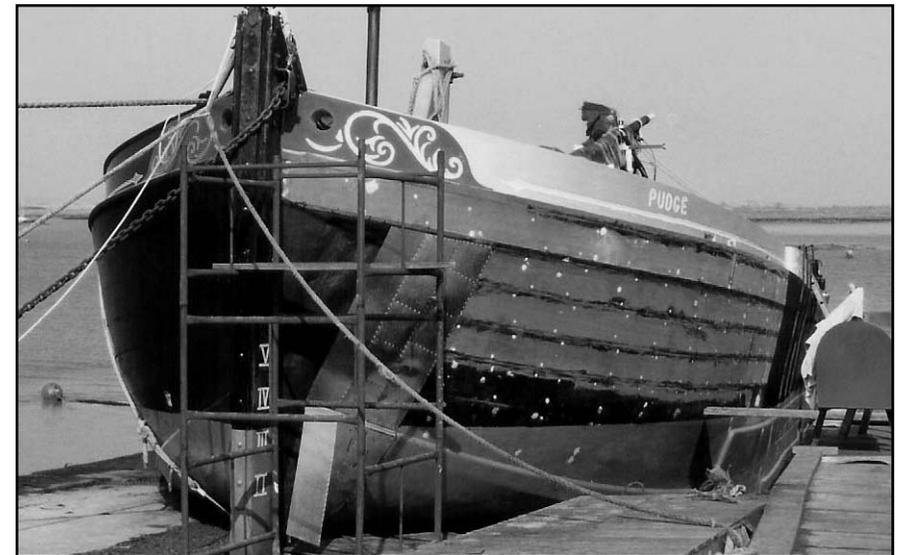
The new bow badges are clear in the picture as is the shape of the hull. Photo Pat and Peter Boss.

I cut and shaped the boards in 3" iroko and took them to Mike Seymore who had carved Centaur's new bow badges some years ago. Mike produced the superbly carved badges and Rick fitted them at Maylandsea. I had to drill out the hawse holes and subcontracted the work of making up the metal hawse pipes. The final phase of the job was the replacement of the galley and Pudge returned to Maldon for the 2002 season looking like a new barge from for'ard!
